Assessment of risk arising from employees' exposure to noise in the workplace - Australian Scholarship Group

Executive Summary

OBSERVATIONAL OCCUPATIONAL HEALTH AND SAFETY WALKTHROUGH SURVEY RESULTS

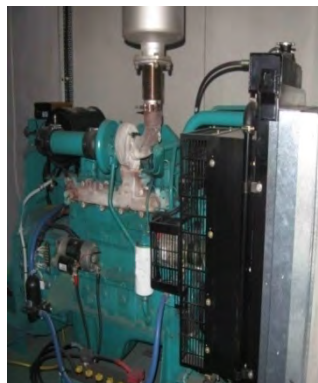
Generator

The findings for this location were 87 to 91 dBA at 9:00 am, followed by 87 to 92 at 1:00 pm and 87 to 91 dBA at 4:30 pm. The results indicate that exposure limits were exceeded. The generator room is a confined space containing the generator, cleaning chemicals and maintenance equipment. Electrical wiring was not tagged and access door surrounded by rubbish bins. The access fire door is inadequate and be replaced.

| <p>a. Signs that indicate hearing protection are to be worn in the vicinity of the generator.</p> <p>b. The generator room door is replaced and a heavy noise insulated door be installed.</p> <p>c. A battery powered warning light is installed outside the generator room in the event of an emergency.</p> | <p>d. Ensure that all rubbish bins and other materials are kept well clear of the entrance to the generator room.</p> <p>e. Vibration measurements are taken of the generator to provide a baseline for future maintenance.</p> <p>f. Advice to staff by email, telephone or in advance when the generator is to be operational.</p> |

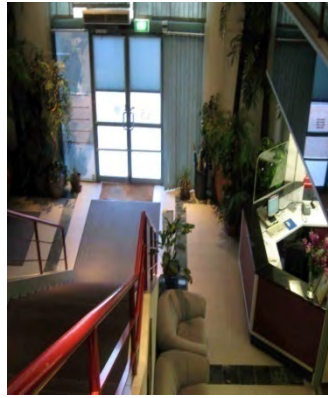
1.Reception (69 dBA)

The findings for this location were 62 to 68 dBA at 9:00 am, followed by 63 to 69 at 1:00 pm and 65 to 68 dBA at 4:30 pm. The results indicate that exposure did not exceed the limits. The reasons for this are due to the thickness of the walls and the concrete floors that separated the first floor from the generator.

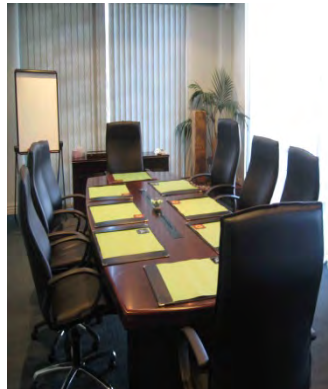
3.Board Room (63 dBA)

The findings for this location were 60 to 62 dBA at 9:00 am, followed by 60 to 62 at 1:00 pm and 60 to 63 dBA at 4:30 pm. The results indicate that exposure did not exceed the limits. The reasons for this are due to the thickness of the walls and the concrete floors and the distance from the generator.

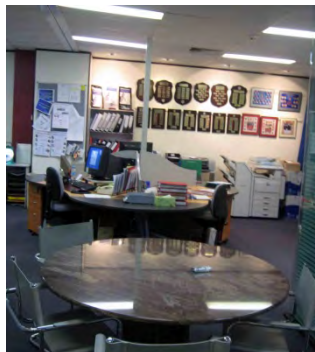
5.Staff amenities (82dBA)

The findings for this location were 62 to 82 dBA at 9:00 am, followed by 63 to 81 at 1:00 pm and 62 to 61 dBA at 4:30 pm. The results indicate that exposure did not exceed the limits.

The reasons for this are due to the thickness of the walls and the concrete floors and the distance from the generator. The higher readings were due to the windows being left open that included street and vehicle traffic noise in the measurements.

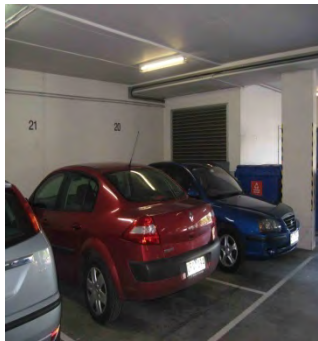
9. Car park (90 dBA)

The findings for this location were 90 dBA at 9:00 am, followed by 90 at 1:00 pm and 89 to 61 dBA at 4:30 pm. The main reason for the high measurements was due to the street and traffic noise.

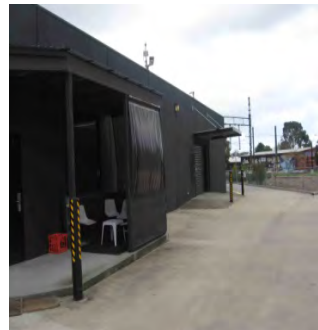
13. Car park (79 dBA)

The noise measurements being taken of the car park and smokers' area were to measure the difference between street and internal noise sound levels. Street noise, vehicle traffic and trains were the main source of noise.

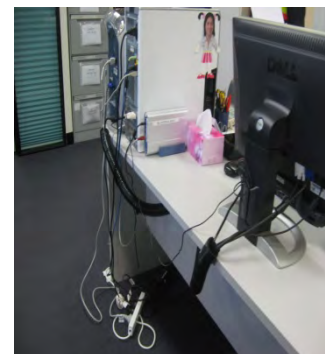
Work station wiring

The electrical wiring leads were found entangled on the floor near the staff walk through aisle creating a hazard when walking past the workstation. It is suggested that electrical wiring be secured.

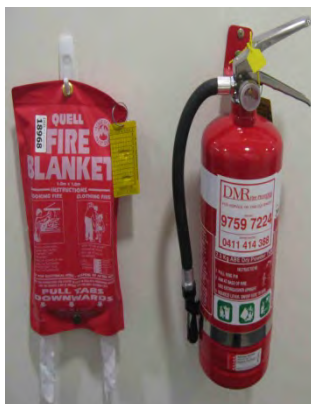
Call Centre extinguishers

3. Call Centre extinguishers. A powder fire extinguisher was found which if used may clog the electrical systems. It is suggested that a CO2 extinguisher be installed to replace the powder type.

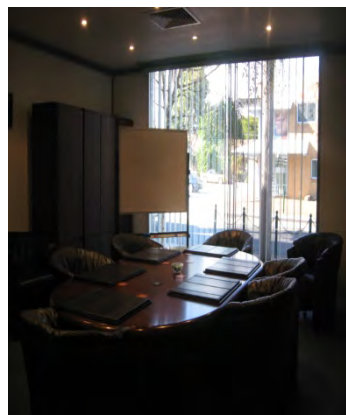
Board room access

4. Board room. The board room is sound-proof and locked from within. This constitutes a fire hazard if a fire is in the board room. Access to the board room is not available for any person attempting to enter. It is suggested that locks be changed.

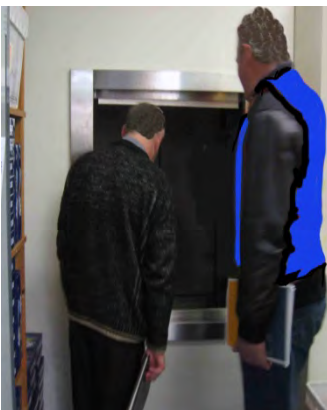
Contractors & Visitors

5. Contractors. A check of the visitors' sign in book was conducted and found that it had not been completed for the day. It is suggested that all contractors and visitors sign in the visitor's book held at the reception in both buildings.

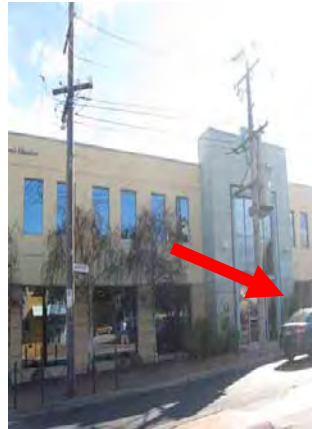
Vehicle car exit lights

The vehicles entering and leaving the premises from the main building are blind to the public and outer traffic. It is suggested that suitable flashing lights be installed to forewarn the public and traffic.

- **Cleaning chemicals & maintenance equipment.** Appropriate storage of these items stored in a suitable facility in line with OHS regulations 2007.
- **Warning light at car park entrance.** A warning flashing light be installed at the front of the main building to warn external traffic of vehicles exiting.

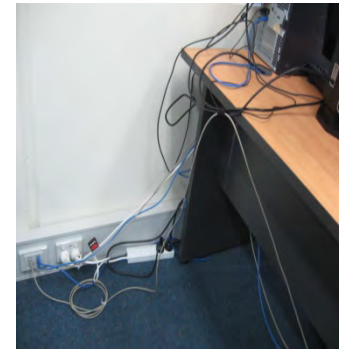
Electrical wiring

The wiring in the photograph indicates the poor wiring practices throughout the two premises. The computer cables should also be separated from the electrical leads

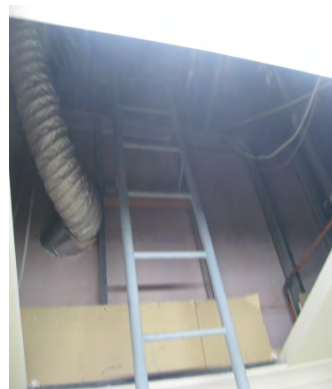
Roof Access

11. Roof Access. A harness & lanyard lines was stored within the storage room for access to the roof. It is suggested that an engineer be consulted to ensure that the bar or metal support can hold the weight of an average person.

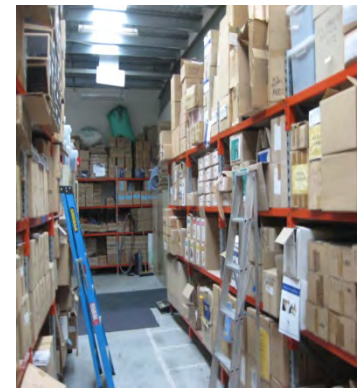
Storage

12. Storage. The warehouse educational supply & administrative records storage should have a long reach racking ladder. Ladders should be in all locations to reduce risks and the onset of shoulder pain associated with manual handling.

- **Ladders in warehouse.** Consider purchasing additional ladders for the warehouse storage areas. To reduce health disorders arising from manual handling.

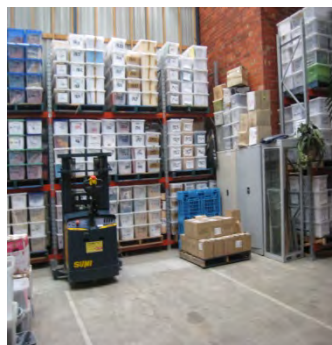
Forklift

13. Forklifts Victoria has a zero tolerance policy on the unsafe & illegal control forklifts driving. A check of operator's credentials confirmed certification. It is suggested bollards be installed to minimise damage to shelves.

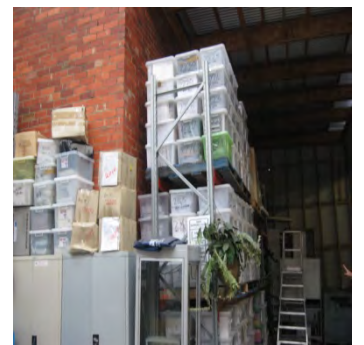
Racks

14. Racking It is suggested that shelving be secured to the walls by a steel chain, bolts and/or steel plates to stop the onset of any damage to the shelves. Securing shelves will reduce rocking effect.

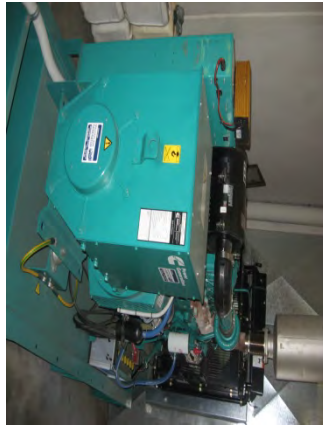
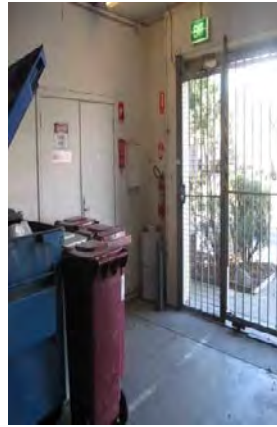
The generator room is a confined space. Cleaning and Maintenance contractors store cleaning and equipment within the room. It is suggested that the room be free of equipment and cleaning products. All electrical wiring should be tagged.

- **Generator room.** Removal of all cleaning products and maintenance equipment will assist operators in the performance of their duties. Ensure entrance to the generator is clear of bins, equipment and other material. Consider a First aid kit be installed with the PPE outside the generator room.

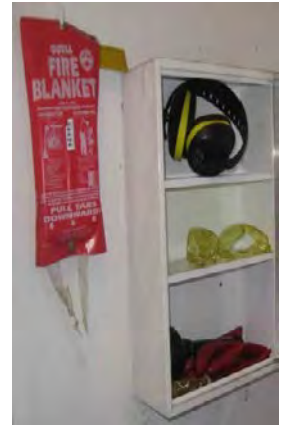
Current ear protection

At the time of the survey, apart from one set of ear muffs located on the right hand side of the access door, there were no other signs of controls in place. The generator room is mounted on a concrete foundation with numerous electrical feeders and air conditioning ducts protruding from the ceiling. The generator has a number of moving parts, with only the motor being encased in a metal base drum enclosure to reduce exposure. The door leading to the generator room consists of plywood which does not reduce noise exposure. The generator is operational during OH&S audits and/or whenever a power failure occurs.

The current generator room door is replaced with a solid wooden door to reduce generator noise exposure. Hearing Protective Devices (HPD) to be replaced with approved HPD's. Appropriate signage advising of HPD, first aid kit and generator location be installed in the near term or within 12 months.
