Assessment of risk arising from employees' exposure to noise in the workplace - Australian Scholarship Group

Executive Summary

OBSERVATIONAL OCCUPATIONAL HEALTH AND SAFETY WALKTHROUGH SURVEY RESULTS

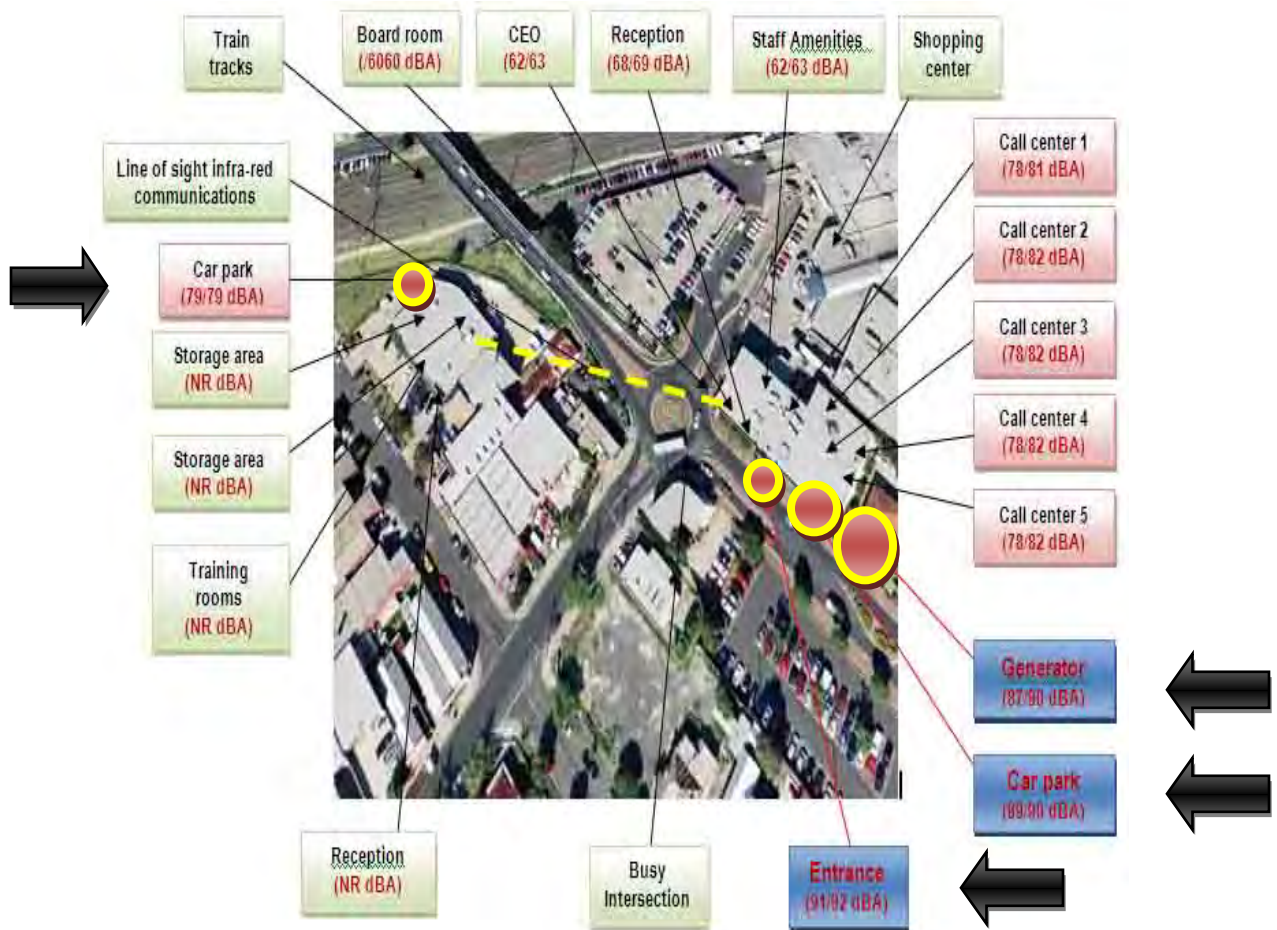
Sound Levels Site Map [8]

In the above site sound level map, distance between buildings can be seen clearly. The three main areas of concern are shown by the round red and yellow dots with black directional arrow. These are clearly marked as front entrance, the car park and the generator room. The car park at the warehouse building can be seen in the top left corner of the site map near the railway lines and the overhead traffic bridge. The line of sight microwave communications is depicted as a yellow broken line. The radio frequencies are directionally horizontally based and are of no harm to the human occupants of the buildings.

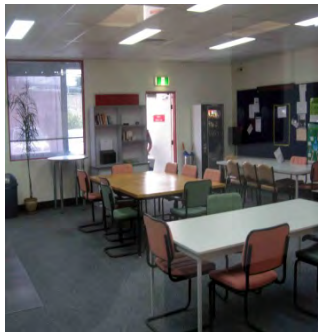
11. Training room (NR dBA)

The findings at this location were quite negligible due to the distance from the generator. Apart from the car park it was considered not necessary to take any noise level measurements. See Annex A for additional information on storage.

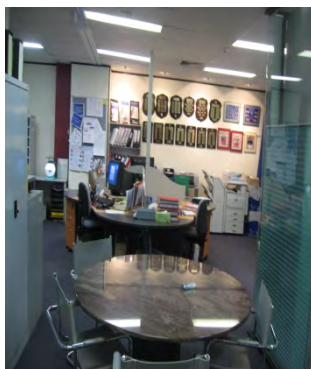
Offices

1. Offices. The main building housing the main offices was found free of any hazards. The assessment concluded that appropriate administrative controls were in place and complied with the OHS regulations 2007.

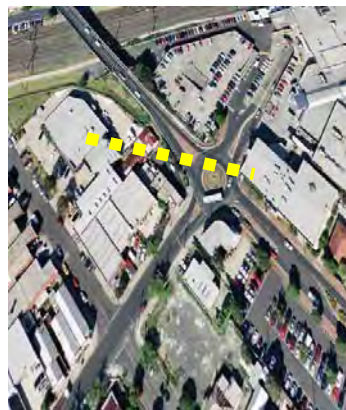
Infra-red communications

6. Infra-red line of sight communications. An observational view of the infra-red line of sight communication network found that it was compliant with current regulations.

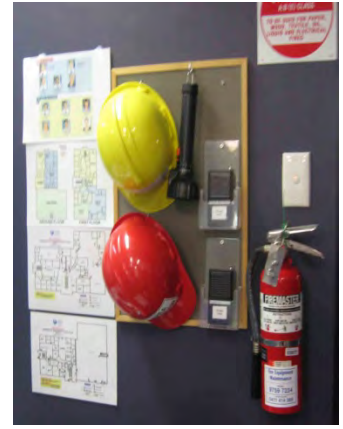
Fire Warden equipment

There are four exit points located near the stairwell which are well equipped with signage. Emergency equipment and devices complied with the regulations.

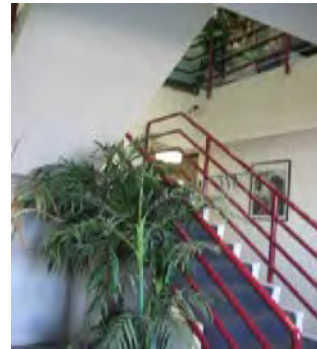
Surveillance cameras

9. Security. Both premises are considered secured from any external threats to person, material, records and information technology.
